# Identification of the Potential Hazards in a Teaching Chemistry Laboratory

**Copyright:** © 2018 Yousif E, Al-Obaidi O, Ali AA, Al-Dahhan WH, Yusop R. Identification of the Potential Hazards in a Teaching Chemistry Laboratory. *Int J Org Inorg Chem*; 1(1): 1-5.

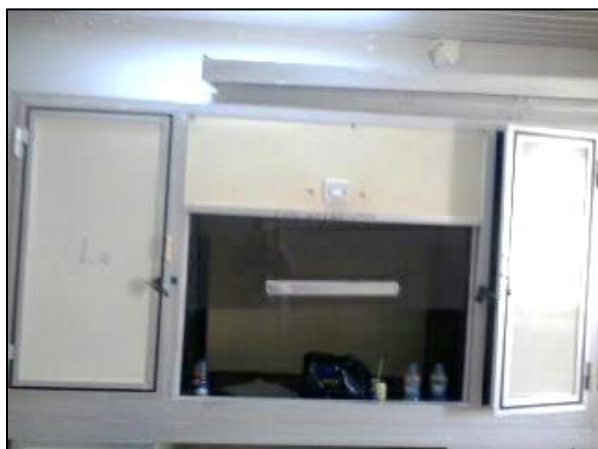
**Figure (1):** Fume hood installed improperly in one of the chemistry laboratories with poor quality and inefficient ventilation system

The problem with that fume hood is that the ventilation was not efficient enough to suck all of the toxic fumes coming out from the chemicals used within. For instance, chloroform is widely known for its toxicity as a liquid and even its fumes if it evaporates. Therefore, we always transfer chloroform and other liquids of similar toxicity strictly inside the fume hood. Unless we make sure that the fume hood is functioning well enough to prevent any damage to people, we could stop using that fume hood till it getting mended or replaced with a functional one. As a matter of fact, the CSSC presented a detailed evaluation report for this laboratory and other laboratories which have a similar issue and below we highlight the most important points the report exposed.

- a) In a country like Iraq, where the summer season is extended to even more than 6 months a year, there must not be a direct exposure to the sunlight to these fume hood in case there are some chemicals stored inside as seen in (Figure 1). Otherwise, all volatile, flammable, and toxic chemicals must be stored away from direct sunlight in a completely dark cabinet below the fume hood cabinet and ensuring that the ventilation is enough within these cabinets.

- b) The ventilation system is not enough to suck all toxic and hazardous chemical fumes. Furthermore, the ventilation fan speed should be variable upon the volume of harmful gases inside the fume hood. In other words, higher volume of fumes inside the fume hood must be sucked in a higher speed and vice-versa.

- c) The sash was not moving up and down easily due to the poor design. This will lead to leaking some of the harmful gases from the fume hood as the ventilation is not efficient. Also, it is always a good practice to keep the sash down whenever there is a reaction inside or the fume hood is not in use.

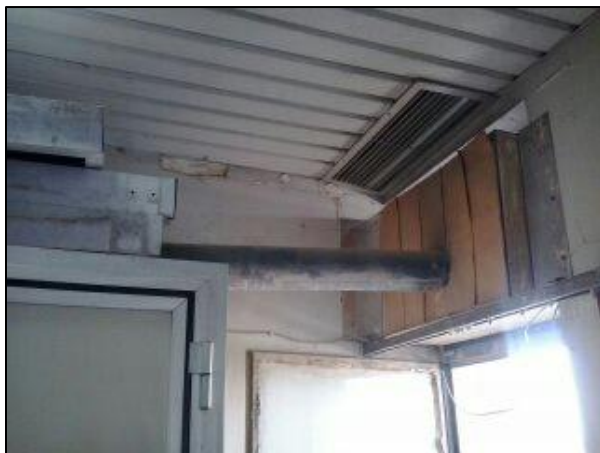
- d) The ventilation ducts supposed to be terminated at the roof of the building and not as seen in (Figure 2).

**Figure (2):** Incorrect and unsafe installation of the ventilation ducts at a very low height and not to the roof of the building.

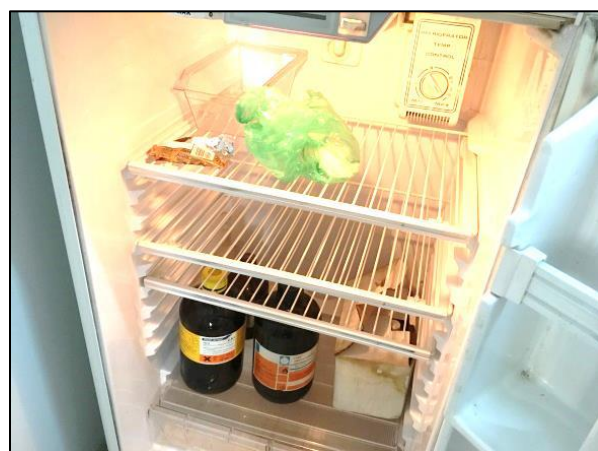
e) Using a chemicals fridge for preserving food and drinks which completely contradicts with safety measures and practices inside any scientific laboratory as displayed in (Figure 3). Drinks and food might be contaminated with chemicals which are all considered as hazardous materials. This contamination may lead to death even with very minimum amounts of those materials, such as selenium, or may be harmful to specific organs for the long run, such as methanol which may cause visual impairment or even full blindness in some serious cases.

**Figure (3):** A fridge inside the laboratory which supposed to be used for storing chemicals and was used to preserve food instead.

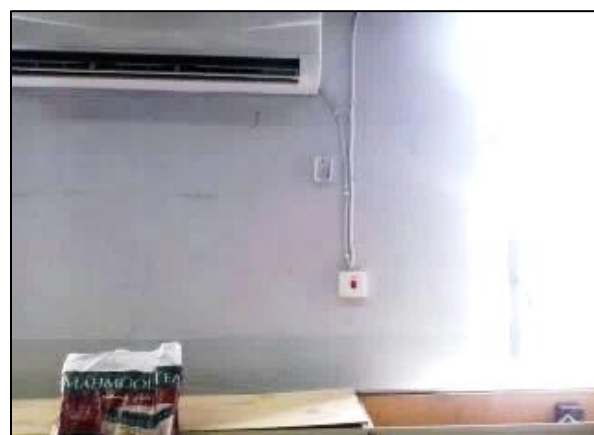
- f) The cooling system is supposed to be central and not as separate units (Figure 4.) in each laboratory and also the electrical cords must be covered with at least a protective PVC tubes to protect them from being in contact with liquids especially water [15]. Also, these electrical cables might be dangerous as electrical shocks are possible in case one of these cables was not properly insulated.
- g) Some electrical cords were found in a very close proximity to some obsolete drainage pipes as shown in (Figure 5). These old pipes might be leaking due to old seals, and fittings. This leakage on these electrical cords may yield a catastrophe and cause a severe damage to the property and people as well.

**Figure (4):** A cooling split unit installed in one of the laboratory with cables fixed on the wall with no cover.

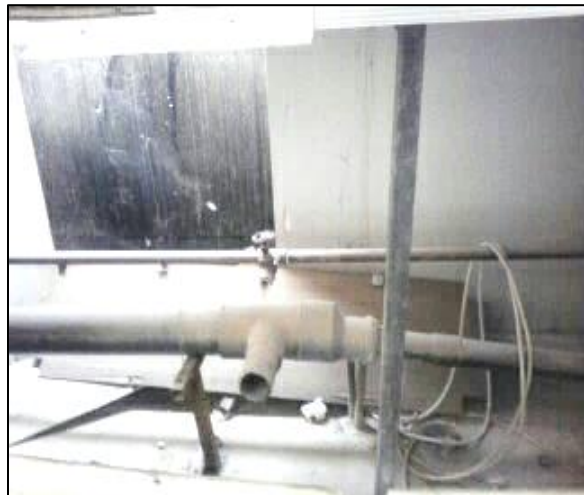
**Figure (5):** The old drainage with some electrical cords in the vicinity.

The CSSC during their audit confirmed that chemical must not be disposed to the sink, and instead must be disposed into waste bottle and the waste bottle should be carefully chosen. For instance, organic liquids, such as toluene, must be disposed to a glass bottle as toluene can react with plastic containers. The CSSC still working on finding an environmentally benign way to dispose waste after the collection to prevent any damage to our environment. The CSSC also acknowledged that any future electrical or plumbing renovations must be under their agreement and direct supervision and according to safety rules.
